Pressurized Water Reactor  
B&W Technology  
Crosstraining Course Manual

Chapter 16.0

Davis-Besse Loss of All Feedwater

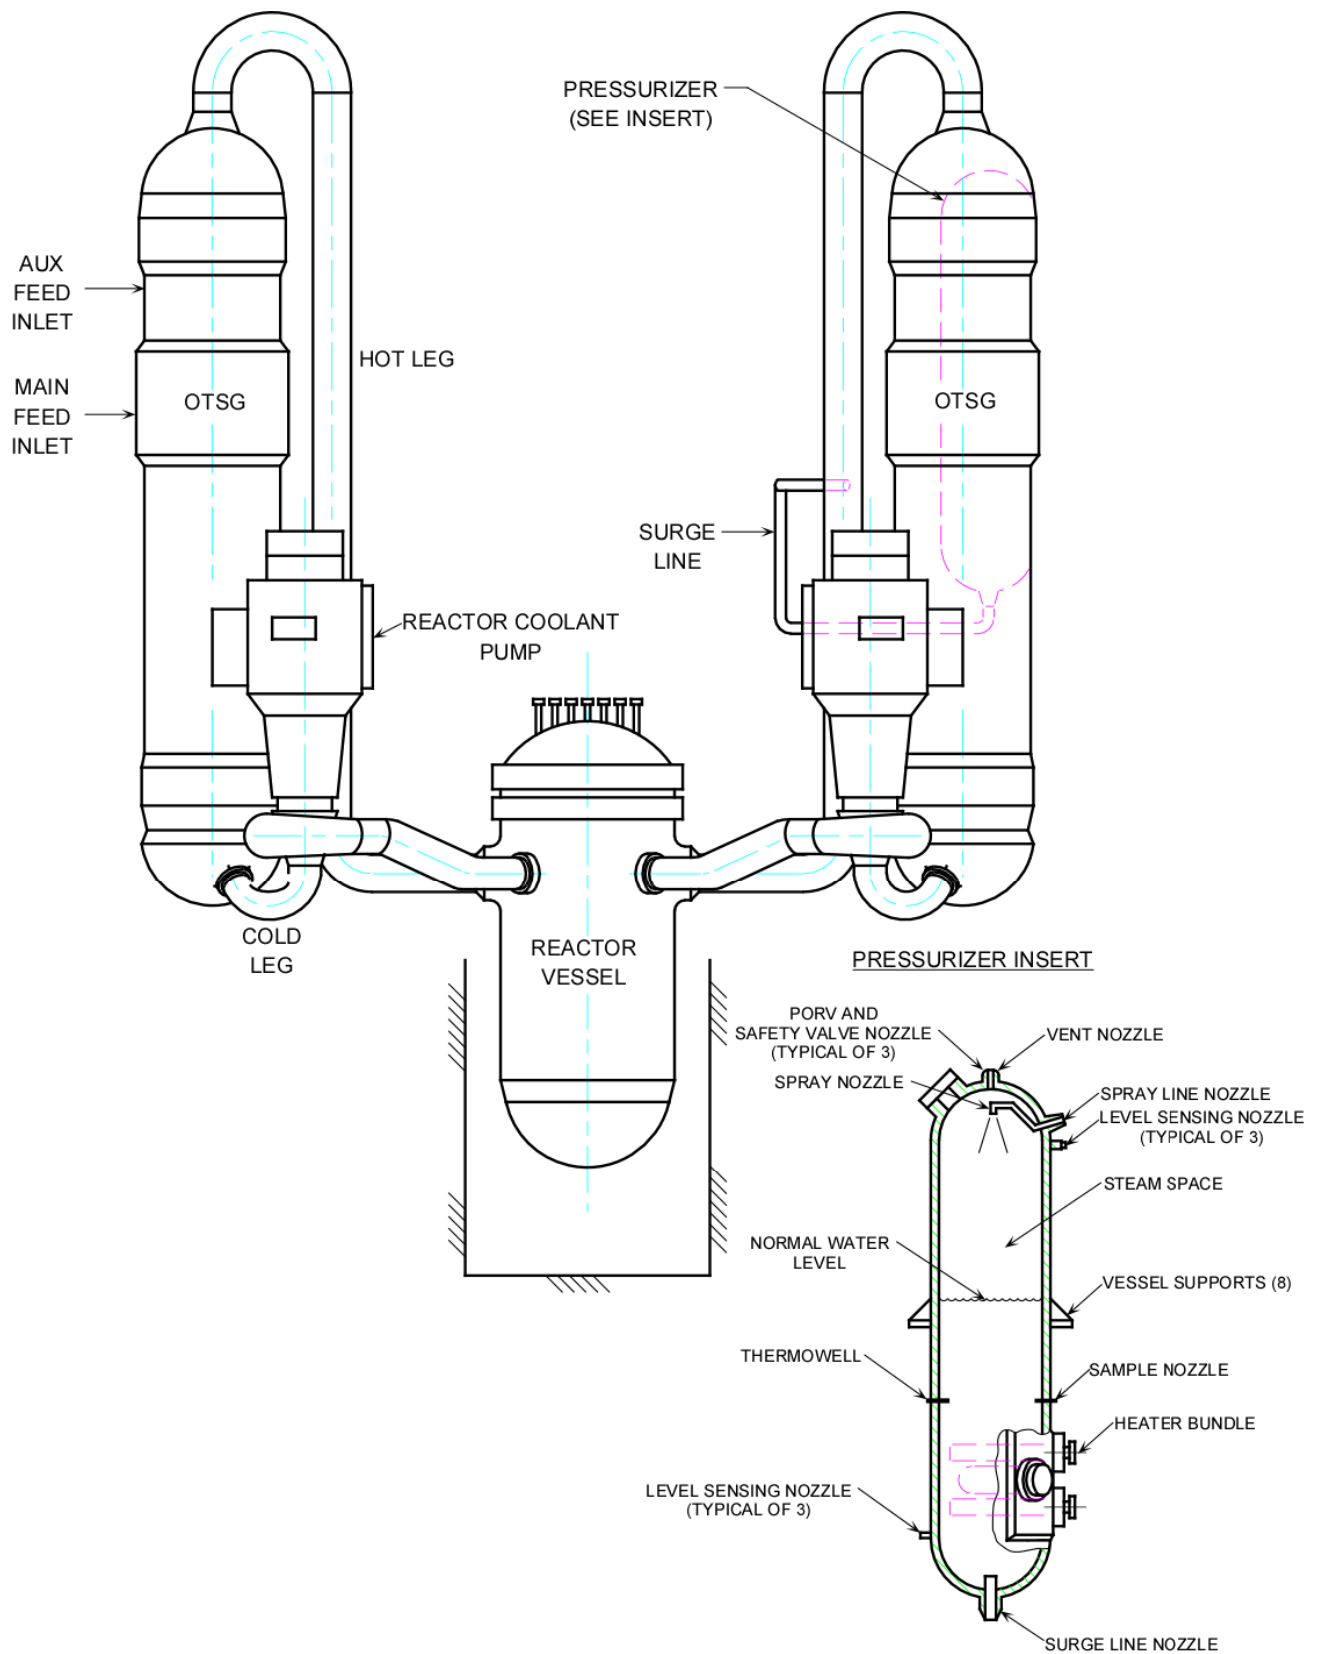
**Figure 16-1 Davis-Besse NSSS**

The Nuclear Steam Supply System (NSSS) for the Davis-Besse plant was supplied by the Babcock & Wilcox Company. The NSSS, shown in Figure 16-1, consists of two heat transport loops with each containing a hot leg, a once-through steam generator (OTSG), and two cold legs. Water from the OTSG is returned to the reactor vessel by the reactor coolant pumps, with one pump located in each cold leg. Reactor coolant system (RCS) pressure is maintained by an electrically heated pressurizer that is connected to one of the hot legs. During normal operations, the pressurizer contains a 700 ft<sup>3</sup> steam bubble that exerts a pressure of approximately 2150 psig on the RCS. Protection against over-pressurization is provided by the pilot operated relief valve (PORV) and two code safety valves. The pilot operated relief valve discharges to a quench tank. The two code safety valves discharge directly to the containment building.

At the top of the pressurizer as shown in Figure 16-1, there are two code safety valves which vent directly to the containment atmosphere, a high-point vent line, and the pilot operated relief valve (PORV) with its associated upstream block valve.

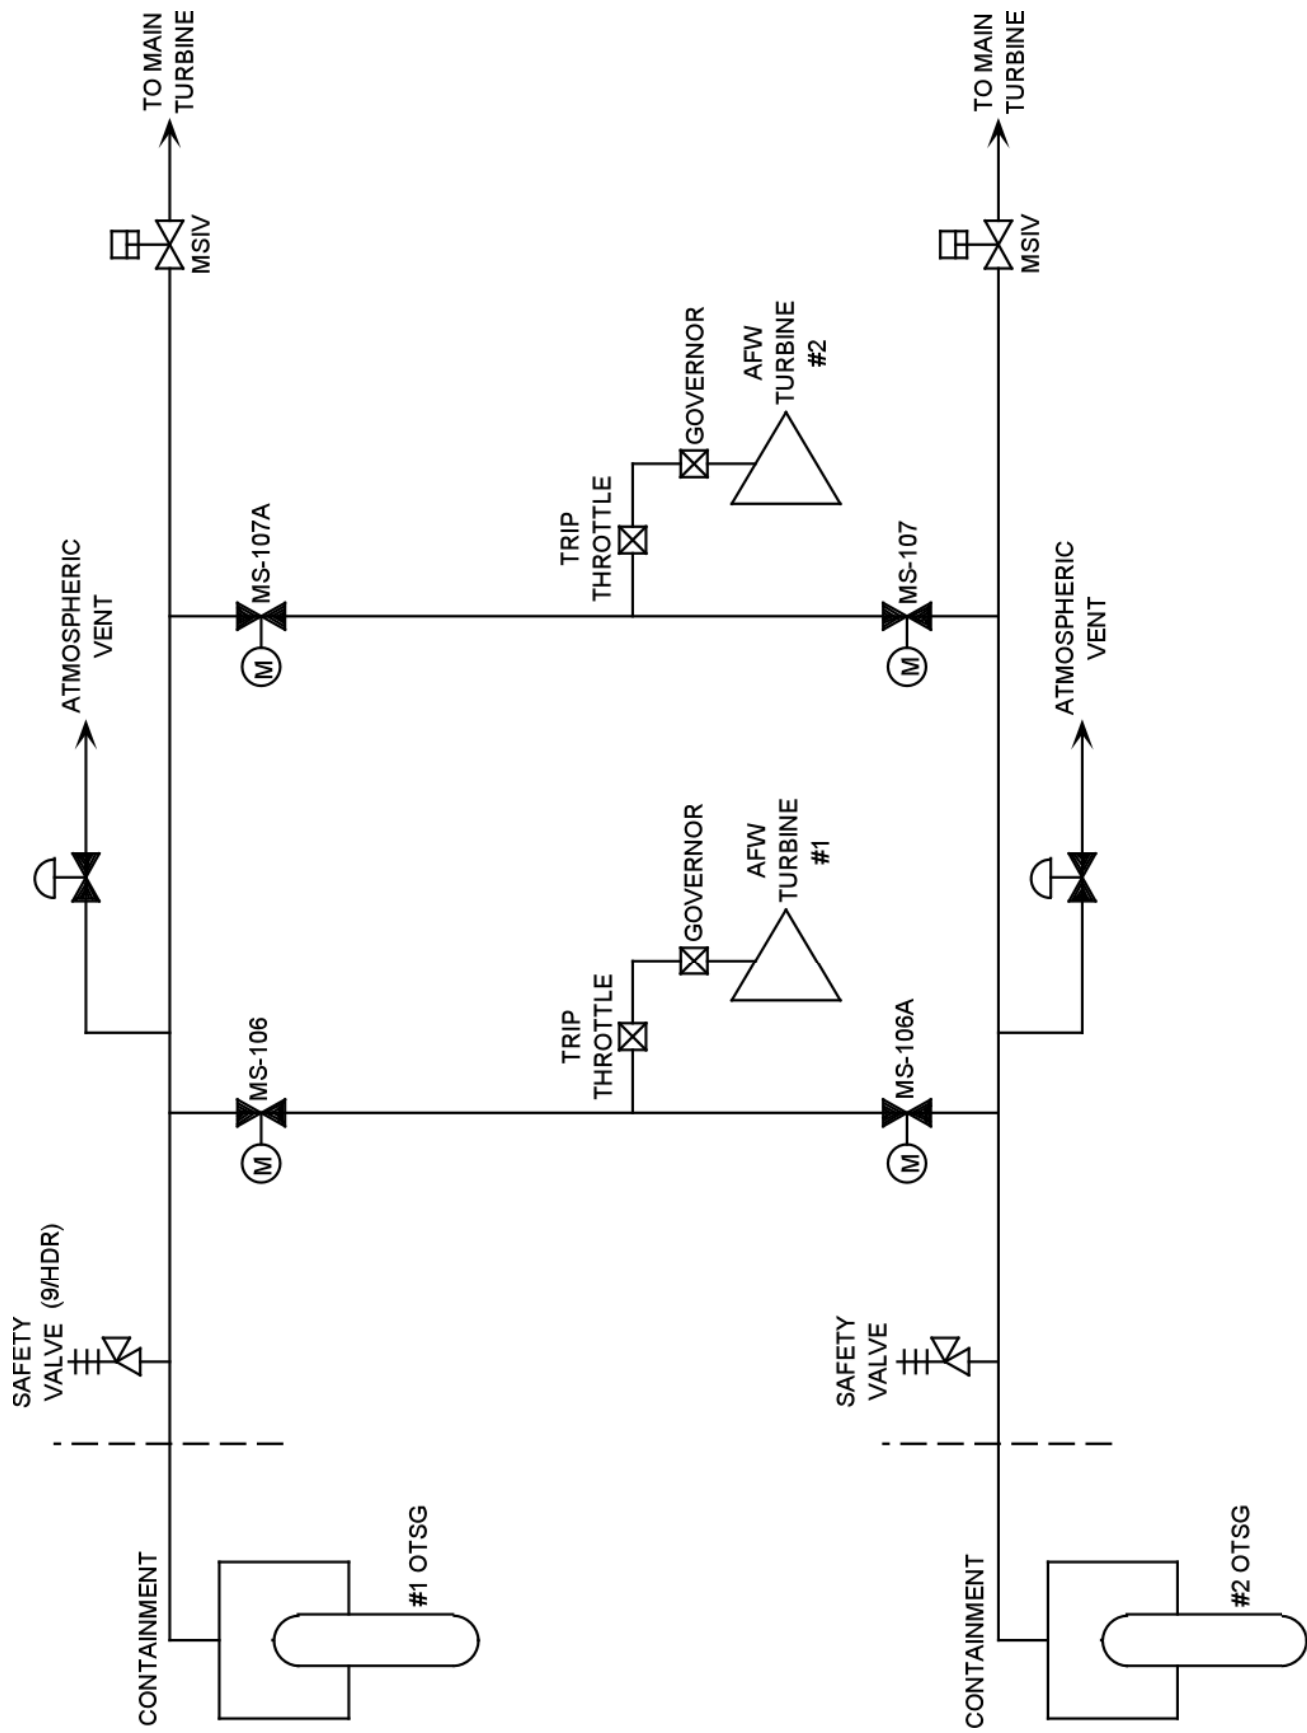
Figure 16-2 Main Steam System

The main steam system functions to deliver superheated steam from the steam generators (OTSGs) to the main turbine and required plant auxiliaries. As shown in Figure 16-2, the system begins with the outlet piping from the steam generators and passes through the containment building to the main steam isolation valves (MSIVs). Protection against overpressurization for the steam generators is provided by 18 code safety valves (9

per steam generator) located on the system piping upstream of the MSIVs, and two atmospheric vent valves (one per steam generator) which act as relief valves. The atmospheric vent valves are controlled by the integrated control system (ICS) and aid in controlling steam pressure if a large transient occurs when the unit is in service, if condenser vacuum is lost, or if the MSIVs are closed. Connections upstream of each main steam isolation valve supply steam to the redundant turbine-driven auxiliary feedwater pumps. Either system header is capable of supplying either turbine; however, the auxiliary feedwater pump turbine normally receives steam from its associated steam header.

The piping downstream of the MSIVs contains non-return valves that prevent reverse flow when steam generator pressures are not equal. From the non-return valves, steam flows to the high pressure turbine and secondary systems, such as the air ejectors.

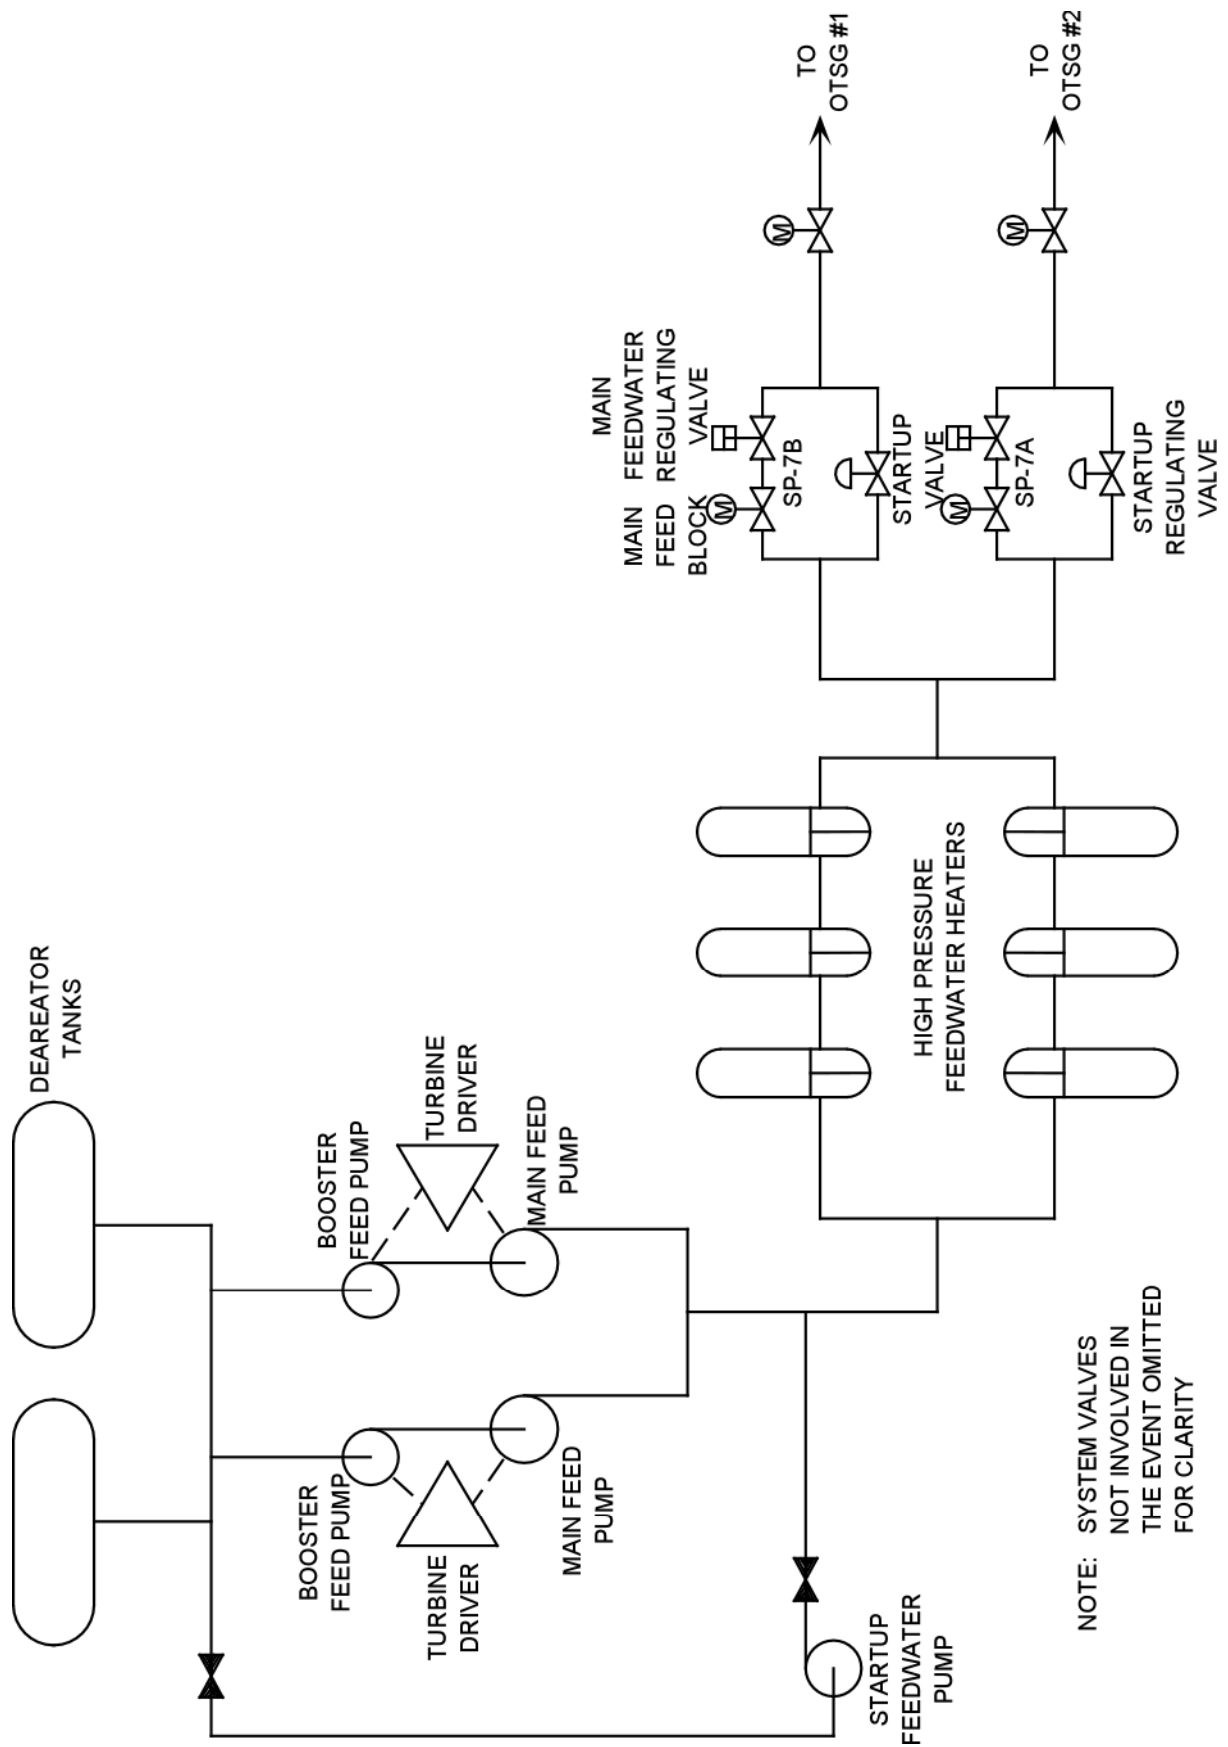
Figure 16-3 Main Feedwater System

The main feedwater system, Figure 16-3, begins with the cross-connected deareator storage tanks. Each of these tanks has a capacity of 64,000 gallons and provides the required net positive suction head (NPSH), i.e. pressure, for the booster feedwater pumps. The booster feedwater pumps are driven through a gear reducer by the main feedwater pump turbines and function to increase system pressure to satisfy the suction requirements for the main feedwater pumps. The direct-driven main feedwater pumps increase feedwater pressure to a value greater than steam generator pressure and discharge through the high pressure feedwater heaters to the feedwater regulating valves.

Two parallel valves are used to govern the flow of feedwater to each OTSG. The first of the two valves is called the startup control valve and regulates feedwater flow from 0% power to approximately 15% power. Startup control valve SP-7B supplies the #1 OTSG,

and startup control valve SP-7A supplies the #2 OTSG. When the startup control valves reach the 80% open position, the main feedwater regulating block valves open, and flow is also controlled by the main feedwater regulating valves. The main feedwater regulating valves control feedwater flow during the power escalation from 15% to 100%. The pressure drop across the valve network is monitored and used to control main feedwater pump turbine speed. From the outlet of the feedwater regulating valves, the feedwater travels to the OTSGs via a motor-operated main feedwater isolation valve. Main feedwater is added to the OTSG through the external main feedwater ring and the main feedwater nozzles.

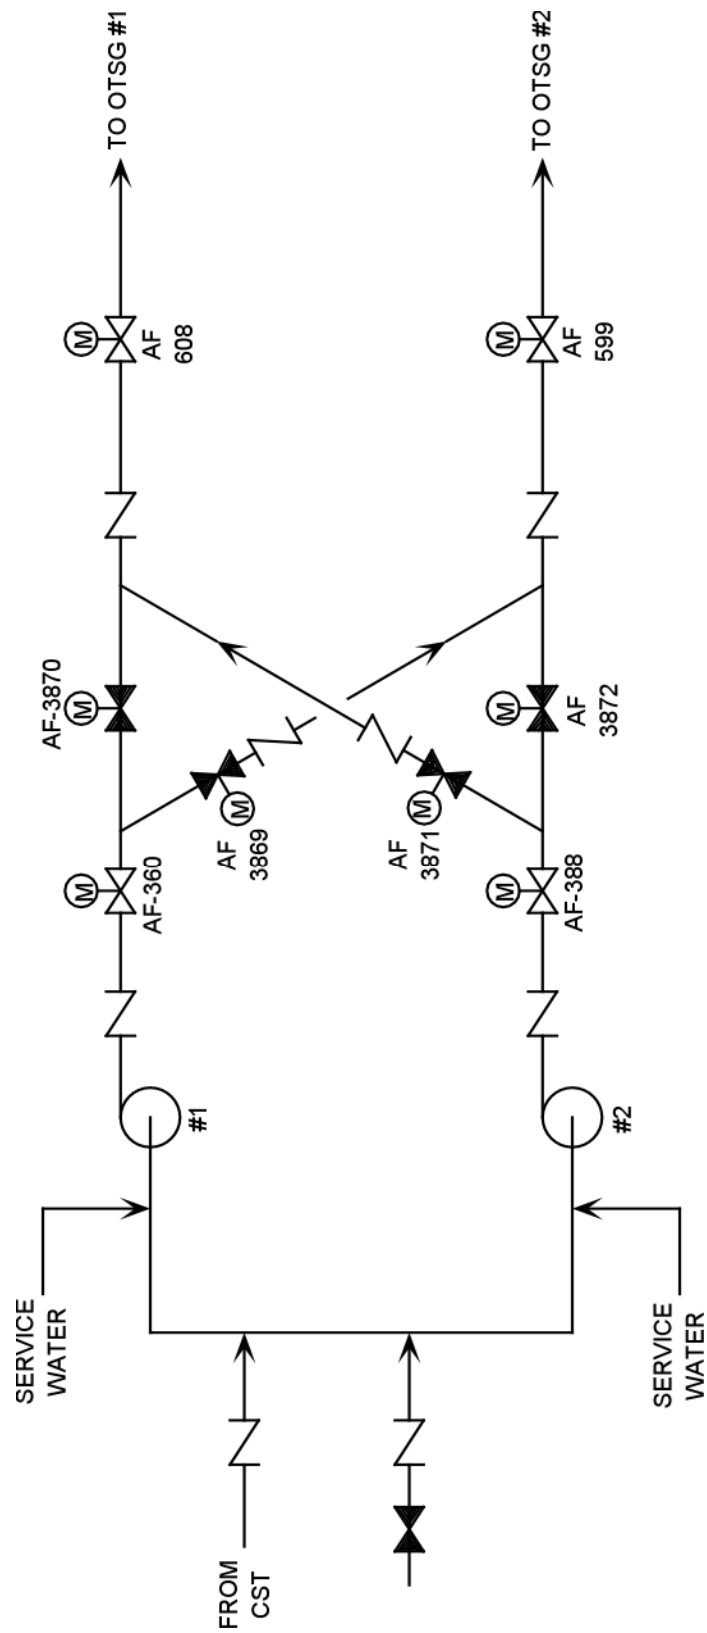
Figure 16-4 Auxiliary Feedwater System

The auxiliary feedwater system (AFW), Figure 16-4, is designed to remove the core's decay heat by the addition of feedwater to the steam generators following a reactor trip, if main feedwater is not available. The system consists of redundant turbine-driven auxiliary feedwater pumps and associated piping. Three suction sources are available to the AFW pumps: the deareator storage tanks, the condensate storage tank (CST), and the service water system. The CST serves as the normal suction source for the system; however, if a low suction pressure condition is sensed, the AFW suction will automatically transfer to the service water system. Manual action would be required to transfer suction to the deareator storage tanks.

When the AFW system is actuated by the steam and feedwater rupture control system (SFRCS) on signals other than low steam generator pressure, the steam to drive the AFW pump turbine and the discharge of each pump are aligned with the associated steam generator. Each of the AFW pumps is rated at 1050 gpm when pumping against a steam generator pressure of 1050 psig; 250 gpm of the 1050 gpm is used for recirculation flow.

The #1 pump supplies the #1 OTSG via motor-operated valves AF-360, AF-3870, and AF-608. The feedwater supply for #2 OTSG is from the #2 pump through valves AF-388, AF-3872, and AF-599. However, if the SFRCS is actuated on low OTSG pressure, the flow path of the system is altered to prevent the feeding of a ruptured steam generator. The isolation of feedwater to the faulted steam generator is accomplished by closing the AFW containment isolation valve (AF-599 or AF-608). Feedwater to the intact steam generator is supplied by both pumps through the appropriate cross-connect valve (AF-3869 or AF-3871). The steam supply valves for the turbine-driven pumps are also realigned to provide steam for both pumps from the intact steam generator. The following listing gives the position of the AFW system valves during various SFRCS actuations:

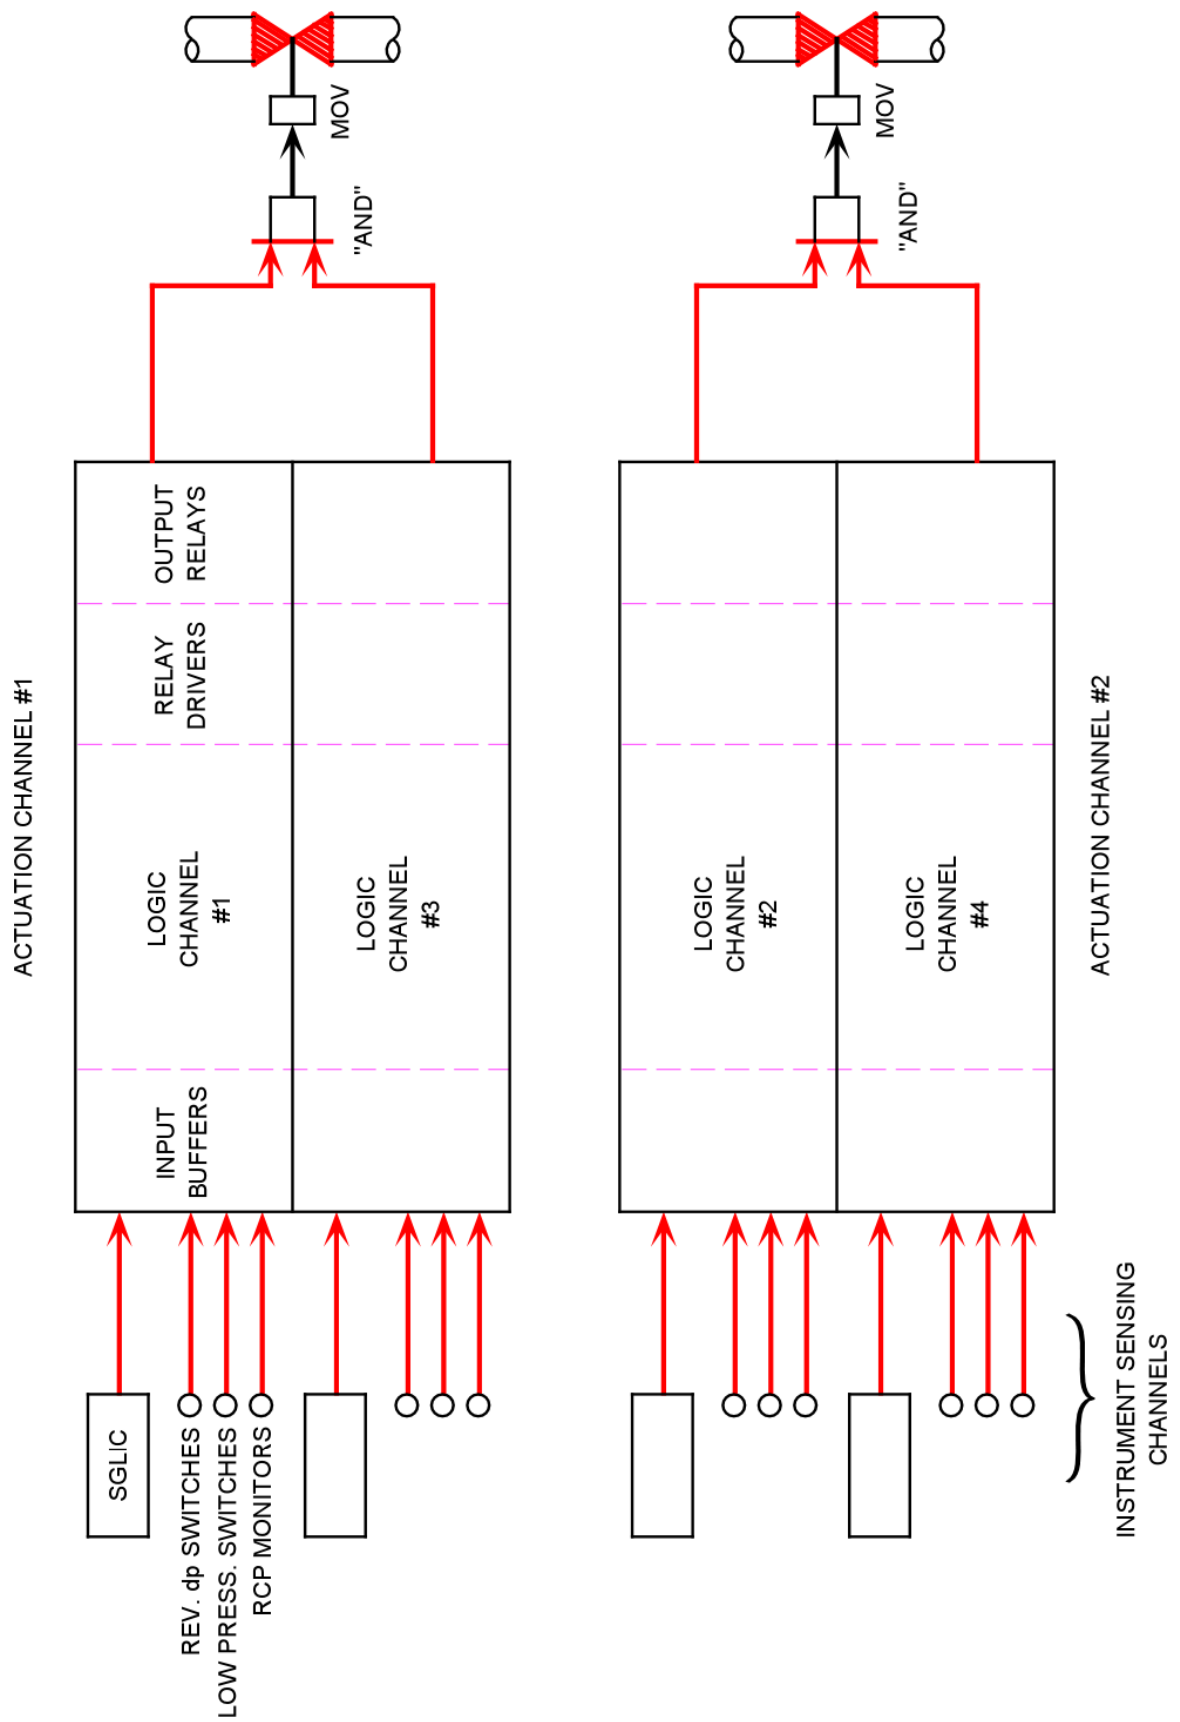
Figure 16-6 Steam and Feed Rupture Control System Logic

Figure 16-6 depicts the channelization of the SFRCS. There are two Actuation Channels, each of which contains two identical logic channels. Within each Actuation Channel, one logic channel is ac powered and the other logic channel is dc powered. The field wiring at the actuated equipment is such that generally both logic channels must "trip" (i.e., a two-out-of-two AND logical arrangement) to actuate most equipment, which is

referred to as a “full trip.” However, some equipment is actuated by a “half trip” (i.e., only one logic channel of an actuation channel has tripped). For example, the atmospheric steam vent valves are closed by “half trips.”

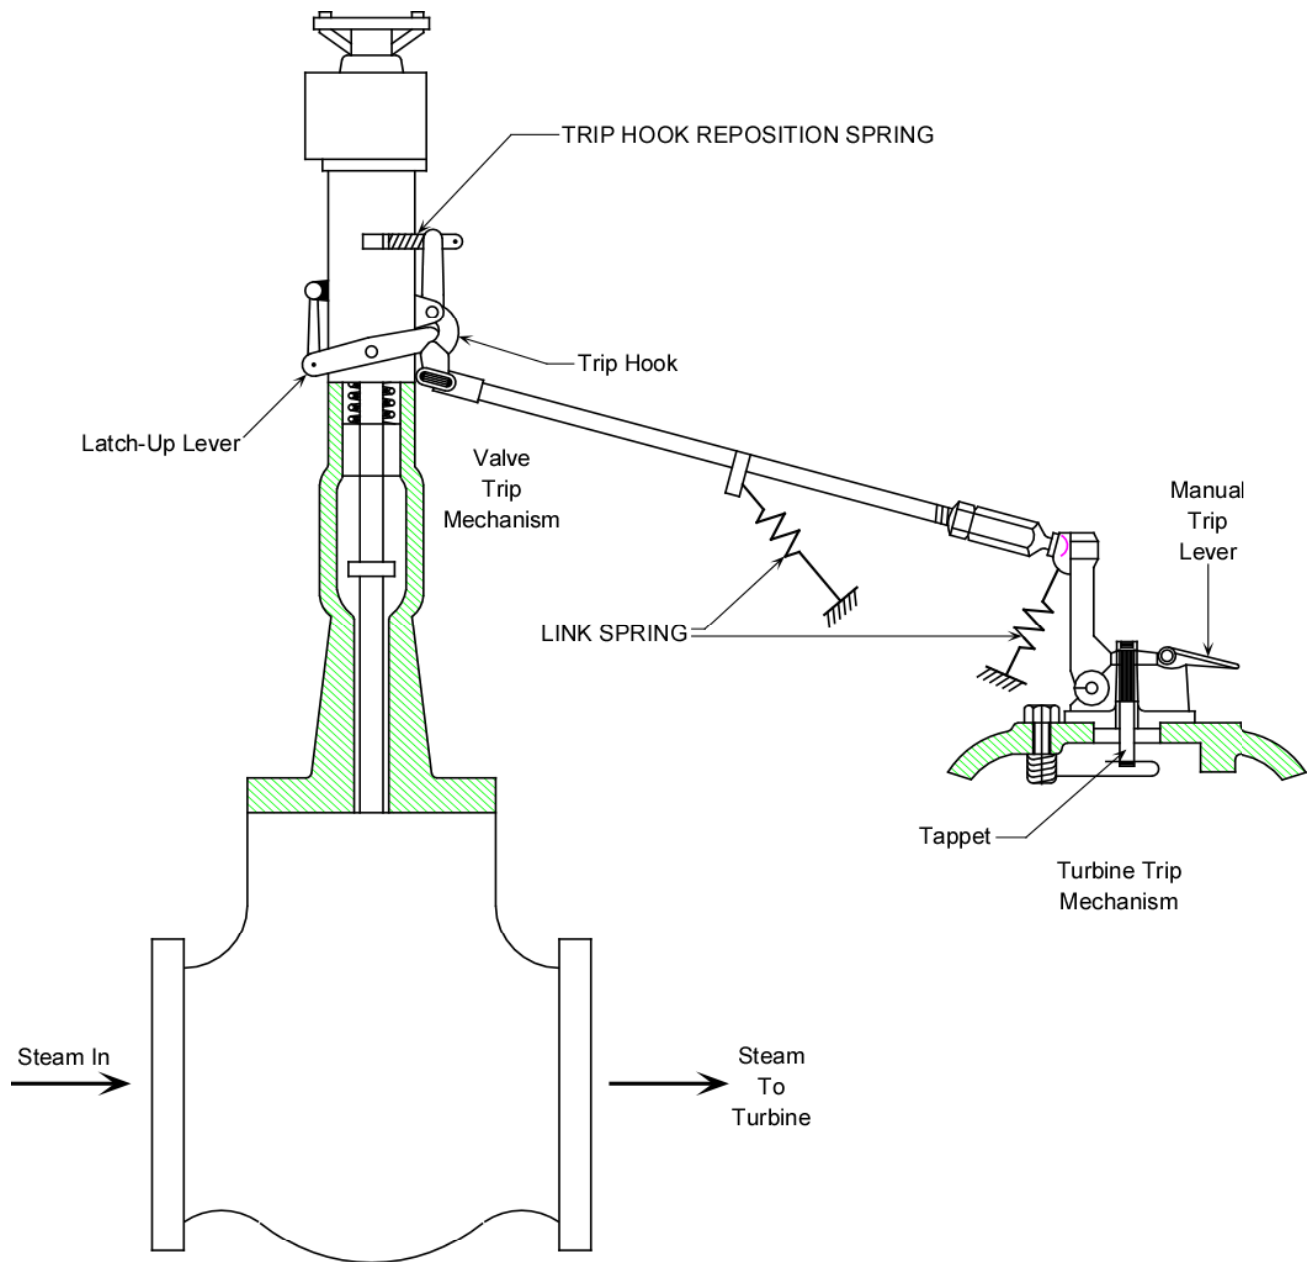
**Figure 16-10 Trip Throttle Valve**

The operators descended the steep stairs resembling a ladder into the No. 2 AFW pump room. They recognized immediately that the trip throttle valve had tripped (Figure 6-10). One operator started to remove the lock wire on the handwheel while the other operator opened the water-tight door to the No. 1 AFW pump. He also found the trip throttle valve tripped and began to remove the lock wire from the handwheel.

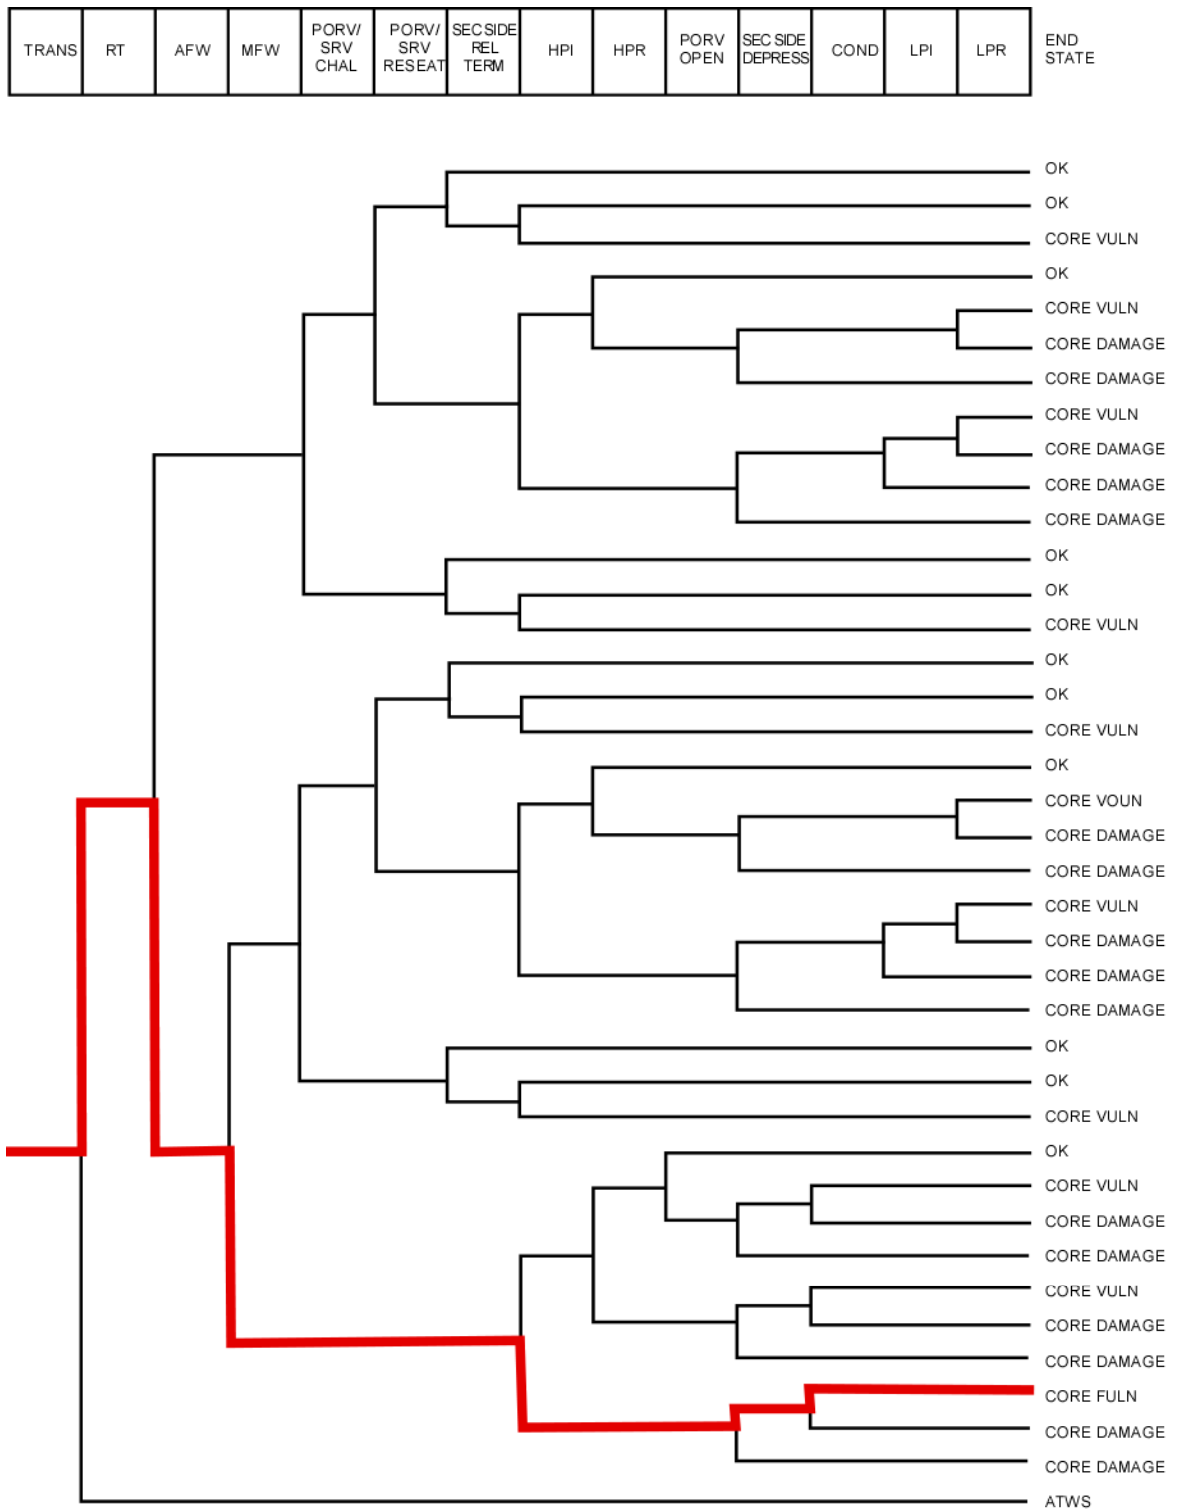
Figure 16-11 Dominant core Vulnerability Sequence Event Tree

A calculation of conditional core vulnerability and core damage probabilities for this event was performed and appears in NUREG/CR-4674, "Precursors to Potential Severe Core Damage Accidents: 1985 A Status Report." The dominant sequence for core vulnerability has a probability of  $9.085\text{E-}03$ , and the event tree for this sequence is shown in Figure 16-11. The dominant sequence for core damage has a conditional probability of  $4.680\text{E-}03$ , and the event tree for this sequence is shown in Figure 16-12. Note that this sequence contains a failure of the HPI feed and bleed. The hesitancy of the shift supervisor to initiate this system could have led to this failure.
